PILOT CASE STUDY: LEAKING UNDERGROUND STORAGE TANK AT A LOW PERMEABILITY SITE IN ONTARIO

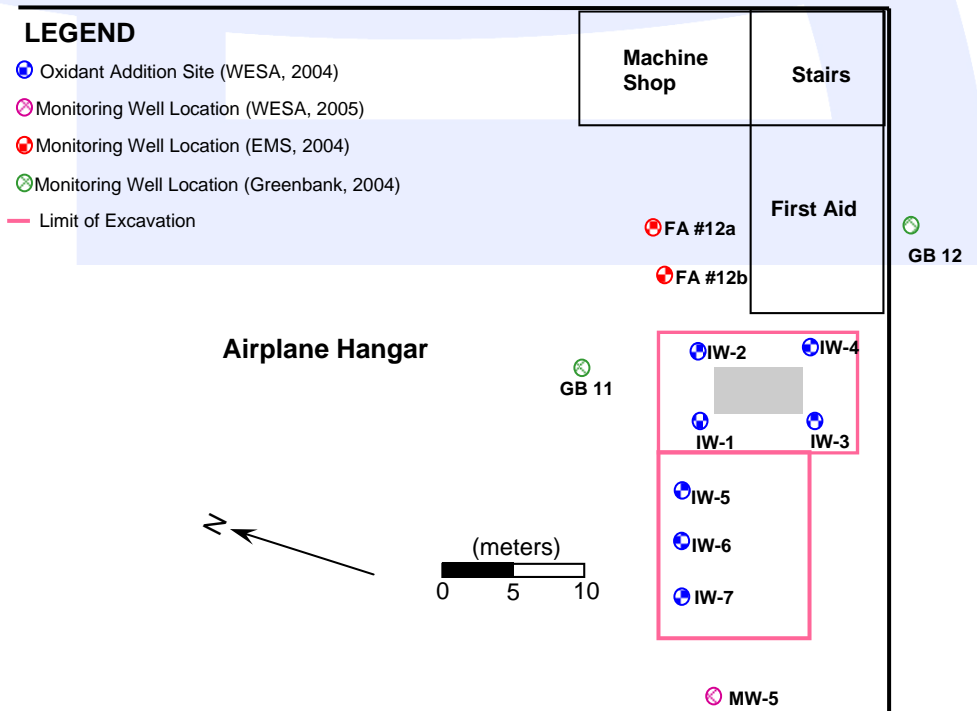
SITE MAP

- Site analysis showed a significant increase in DO at a significant distance from the well as shown below:
 - IW-1: Approximately 4 meters (13 feet) away from IW-6 showed DO changes from 1.78 mg/l – 24.16 mg/l

- IW-2: Approximately 7 meters (23 feet) away from IW-6 showed DO changes from 1.17 mg/l – 18.88 mg/l
 - IW-3: Approximately 6.7 (22 feet) meters away from IW-6 showed DO changes from 1.61 mg/l – 40.00 mg/l

- IW-4: Approximately 10 meters (33 feet) away from IW-6 showed DO changes from 2.95 mg/l – 23.01 mg/l
 - IW-5: Approximately 2.7 (9 feet) meters away from IW-6 showed DO changes from 1.91 mg/l – 24.22 mg/l

- IW-6: Changed from 2.37 mg/l – 50.00 mg/l
 - IW-7: Approximately 2.7 (9 feet) meters away from IW-6 showed DO changes from 2.00 mg/l – 22.86 mg/l
- A small iron removal system (zeolite) was installed ahead of the gPRO[®] HP and removed enough iron such that modules and lines were not fouled

- Storage tank excavated Fall 2004
- Back filled with gravel and perforated piping was added
- gPRO[®] HP system installed January 2006
- Injected oxygenated water into IW-6
